Project Profile

Project Description:	Gilbert Bain Hospital, Electrical Switchboard Replacement
Location:	Gilbert Bain Hospital, Lerwick, Shetland
Client:	NHS Shetland
Project Value:	£100K
Project Duration:	January 2015 - July 2015
Sector:	Healthcare

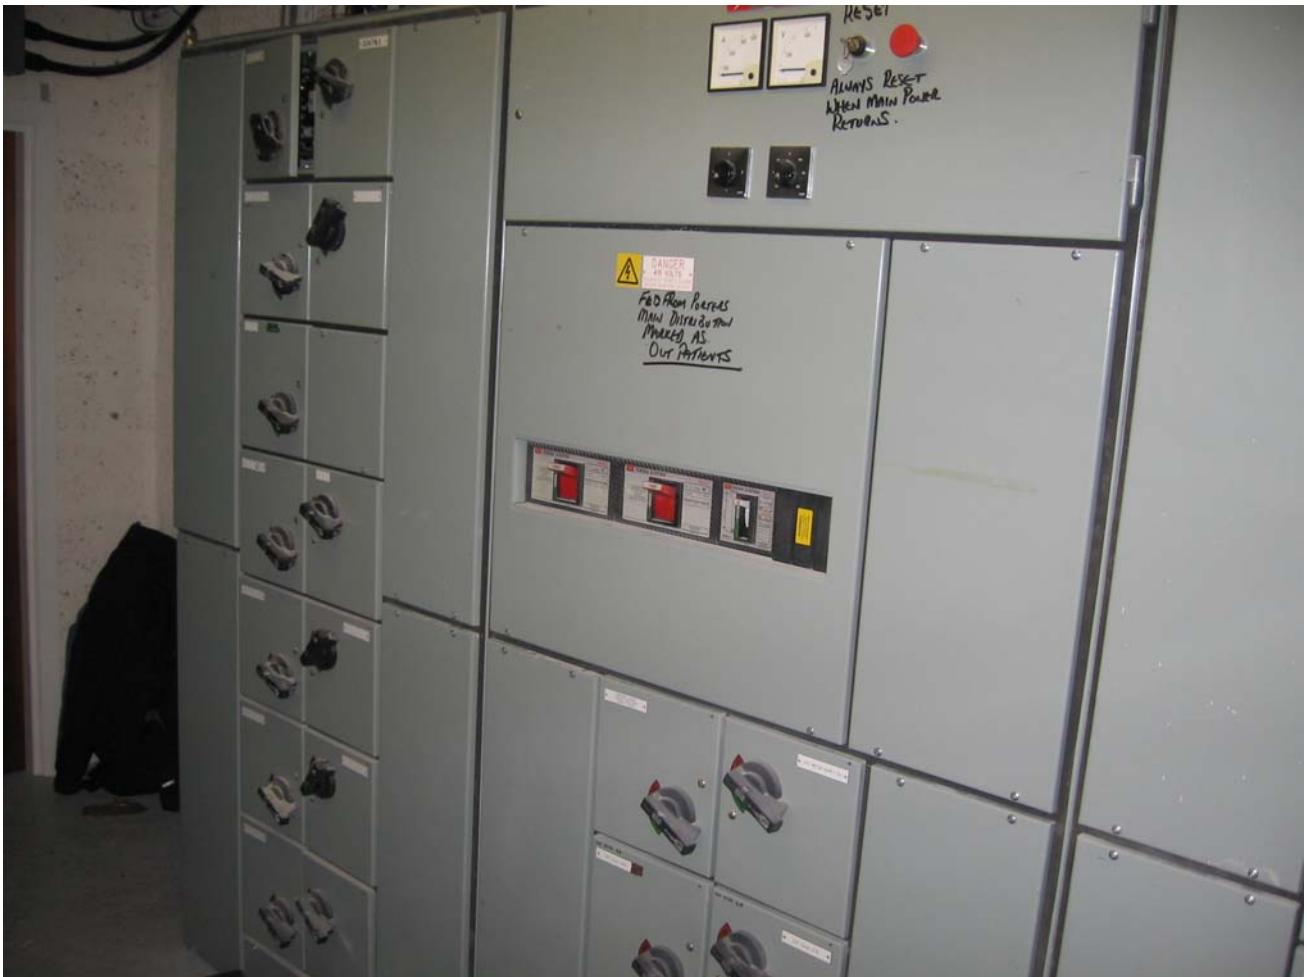
The new switchgear is two separate moulded case circuit breaker (MCCB) panel boards – one serving the non-essential supplies and the other serving the essential supplies. An additional sub main supply from the

main switchboard was installed to serve the second panel board rather than the current change over switch arrangement of the existing switchboard.
